**Flood Control Project Maintenance
Levee Inspections**
LMA District Cover Sheet
Spring 2017 Levee Inspection Results

Reclamation District No. 2085 Kasson

Spring 2017 Levee Inspection Results

Waterway			Bank	Unit Miles
Unit No. 01 San Joaquin River			Left	5.29
	Spring (March - May)	Summer (June - August)	(September - November) Fall	Winter (December - February)
Unit Maintenance Rating (Fall Only)				
Date of Inspection	4/20/2017 - 4/20/2017			
DWR Inspector	Maksim Khashchuk			
Accompanied By	Ralph Timan RD2085

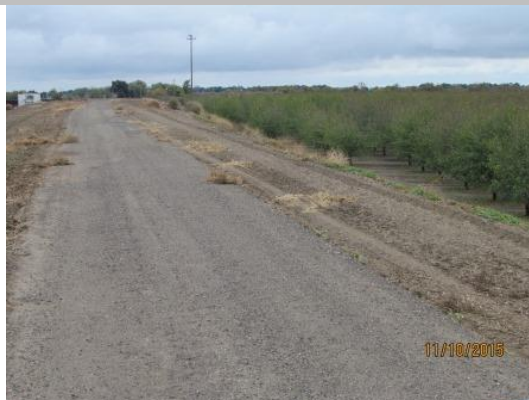
Photo 1 of 1 : SP_2017_RD2085_113_19_20170407_00010.jpg

View of the disking on the levee crown shoulder.

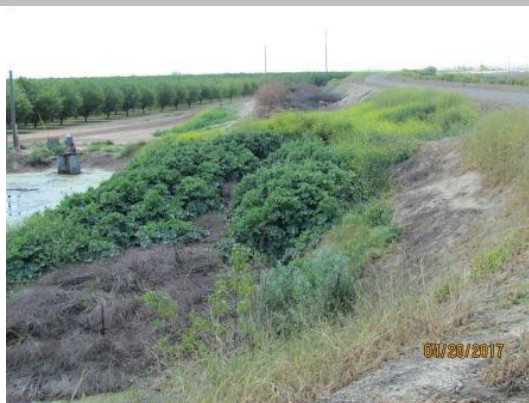
Photo 1 of 1 : SP_2017_RD2085_113_54_20170421_00069.jpg

LM Start	0.46	Rating **	U	Issue No.	54
LM End	0.48	Issue Type +	Ma	Location *	LS
Category	Earthen Levee			GPS Latitude/Longitude	
				Start	End
Item	Vegetation			37.723182 °	37.723383 °
				-121.299549 °	-121.299370 °
DWR ID	DWR_RD2085_01_s_2017_54				
Comment Code					
V1 : Control annual grass and weeds on the levee slopes and easements.					
Inspector Comment

View of the vegetation on the landside levee slope.

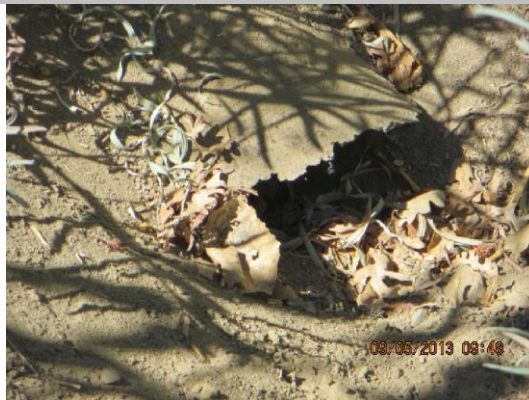
Photo 2 of 3 : UCIP_SP_2017_47170_62261.jpg

Pipe at WS toe.

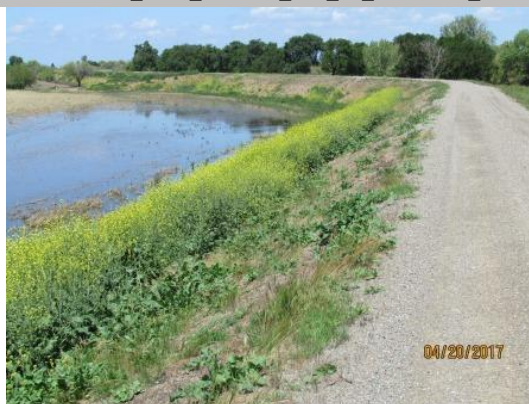
Photo 1 of 1 : SP_2017_RD2085_113_48_20170421_00068.jpg

LM Start	0.70	Rating **	M	Issue No.	48
LM End	1.09	Issue Type +	Ma	Location *	LS
Category	Earthen Levee			GPS Latitude/Longitude	
				Start	End
Item	Vegetation			37.721939 °	37.717553 °
				-121.296102 °	-121.291828 °
DWR ID	DWR_RD2085_01_s_2017_48				
Comment Code					
V1 : Control annual grass and weeds on the levee slopes and easements.					
Inspector Comment

View of the vegetation on the landside levee slope.

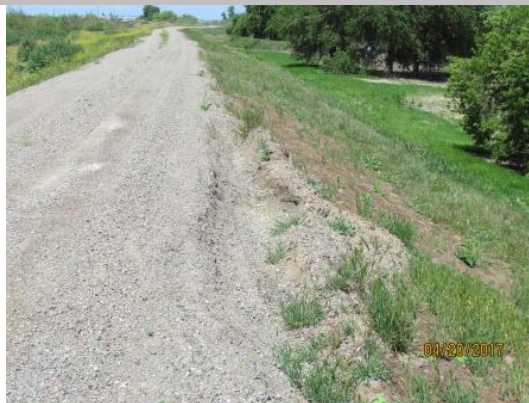
Photo 1 of 1 : SP_2017_RD2085_113_53_20170421_00070.jpg

LM Start	0.87	Rating **	M	Issue No.	53
LM End	0.87	Issue Type +	Ma	Location *	WS
Category	Earthen Levee			GPS Latitude/Longitude	
				Start	End
Item	Slope Stability			37.720142 °	37.720142 °
				-121.294027 °	-121.294027 °
DWR ID	DWR_RD2085_01_s_2017_53				
Comment Code					
S3 : Repair the levee slope damaged by vehicle traffic and prevent access where possible.					
Inspector Comment

View of the tire rut on the waterside levee shoulder.

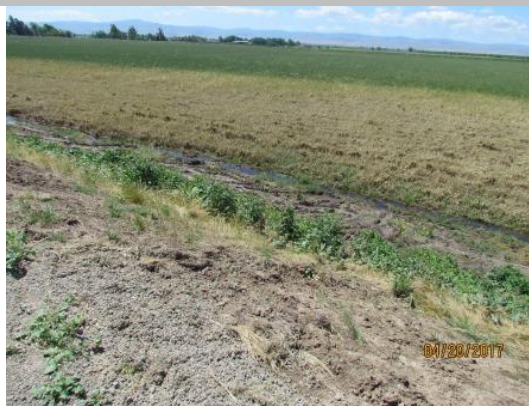
Photo 1 of 1 : SP_2017_RD2085_113_47_20170421_00067.jpg

LM Start	1.18	Rating **	M	Issue No.	47
LM End	1.18	Issue Type +	Ma	Location *	LS
Category	Earthen Levee			GPS Latitude/Longitude	
				Start	End
Item	Slope Stability			37.716216 °	37.716216 °
				-121.291387 °	-121.291387 °
DWR ID	DWR_RD2085_01_s_2017_47				
Comment Code					
S3 : Repair the levee slope damaged by vehicle traffic and prevent access where possible.					
Inspector Comment					
Vehicle ruts on the levee slope and toe.

View of the disturbed landside levee slope.

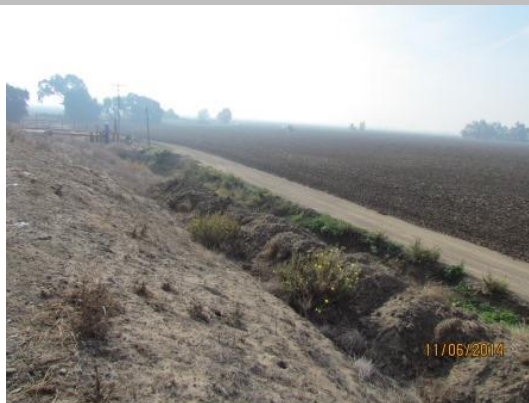
Photo 1 of 1 : SP_2017_RD2085_113_6_20170407_00007.jpg

LM Start	1.34	Rating **	M	Issue No.	6
LM End	1.38	Issue Type +	En	Location *	LS
Category	Earthen Levee			GPS Latitude/Longitude	
				Start	End
Item	Encroachments			37.714265 °	37.714056 °
				-121.289641 °	-121.289069 °
DWR ID	DWR_RD2085_01_s_2012_6				
Comment Code					
DT : Ditch					
Inspector Comment					
Drainage ditch at levee toe.

View of the ditch at the landside levee toe.

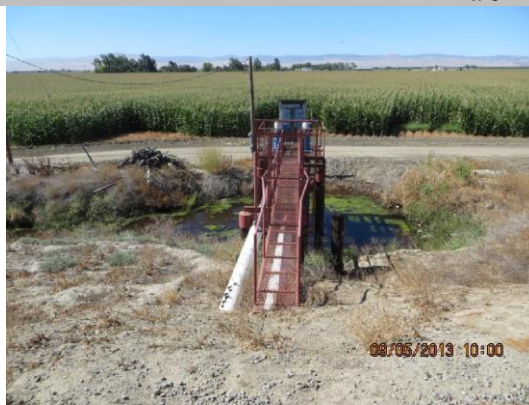
Photo 2 of 3 : UCIP_SP_2017_19384_32927.jpg

Pump on metal pier on LS toe.

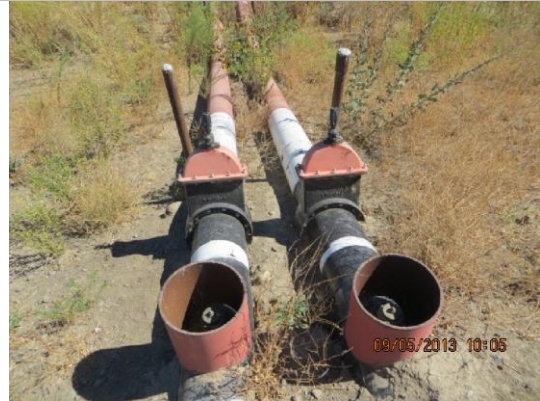
Photo 3 of 3 : UCIP_SP_2017_19384_32926.jpg

LM Start	1.35	Rating **	A/W	Issue No.	56 (cont)	
LM End	1.35	Issue Type +	Ma	Location *	LS	
Category	Supplemental			GPS Latitude/Longitude		
				Start		End
Item	DWR UCIP LMA Responsibility			37.714409 °		37.714409 °
				-121.289479 °		-121.289479 °
DWR ID						
Comment Code						
Inspector Comment						
FS_ID:19384						
DS_ID:20678						
EP_NO: N/A						
Repair Type: No Action Needed						
Crossing Status: Found						
UCIP Comments:						
FIELD_STRUCT_DESC: 12-inch steel stormdrain pipe through the levee 3-feet below the crown. Pump mounted on pile structure in ditch on the landward side. Steel walkway with handrails to the pump structure. Gate valve and Siphon breaker in 12-inch steel riser unit on the waterward shoulder. Originally included in the 1968 O&M manual. (Permit No. 8189, 1972)						
FS Date: 9/5/2013

Pipe, siphon breaker, and gate valve on WS slope.

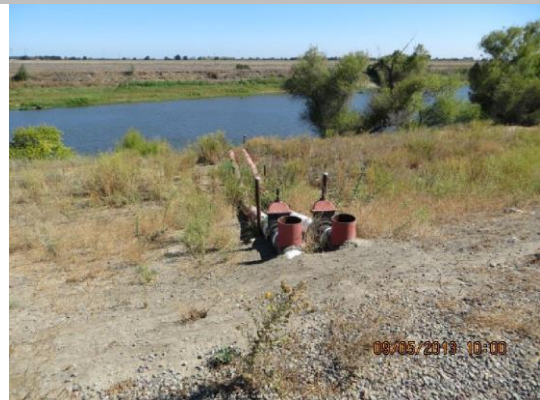
Photo 1 of 3 : UCIP_SP_2017_22285_38010.jpg

LM Start	1.35	Rating **	M	Issue No.	57
LM End	1.35	Issue Type +	En	Location *	LS
Category	Supplemental			GPS Latitude/Longitude	
				Start	End
Item	DWR UCIP Field Study			37.714404 °	37.714404 °
				-121.289469 °	-121.289469 °
DWR ID					
Comment Code					
Inspector Comment					
FS_ID:22285 DS_ID:24055 EP_NO: N/A Repair Type: Non-Urgent Crossing Status: Found UCIP Comments: No permit identified for this modified crossing. FIELD_STRUCT_DESC: 12-inch steel pipe through the levee 3-feet below the crown. Pump mounted on pile structure in ditch on the landward side. Siphon breaker in 12-inch steel riser unit and a gatevalve on the waterward shoulder. (Permit No. 8189, 1972) FS Date: 9/10/2013

Pipe, gate valve, and siphon breaker visible on WS slope.

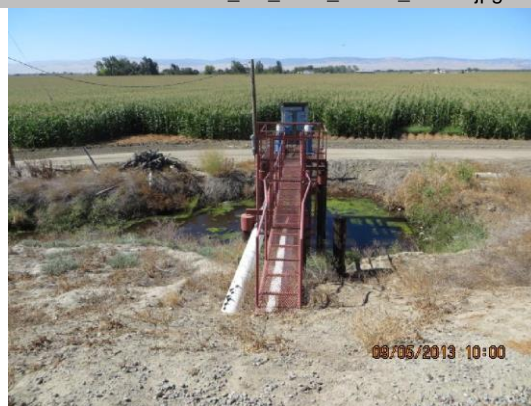
Photo 2 of 3 : UCIP_SP_2017_22285_38009.jpg

LM Start	1.35	Rating **	M	Issue No.	57 (cont)	
LM End	1.35	Issue Type +	En	Location *	LS	
Category	Supplemental			GPS Latitude/Longitude		
				Start	End	
Item	DWR UCIP Field Study			37.714404 °	37.714404 °	
				-121.289469 °	-121.289469 °	
DWR ID						
Comment Code						
Inspector Comment						
FS_ID:22285						
DS_ID:24055						
EP_NO: N/A						
Repair Type: Non-Urgent						
Crossing Status: Found						
UCIP Comments: No permit identified for this modified crossing.						
FIELD_STRUCT_DESC: 12-inch steel pipe through the levee 3-feet						
below the crown. Pump mounted on pile structure in ditch on the						
landward side. Siphon breaker in 12-inch steel riser unit and a						
gatevalve on the waterward shoulder. (Permit No. 8189, 1972)						
FS Date: 9/10/2013

Pipe, pump, and walkway visible on LS toe.

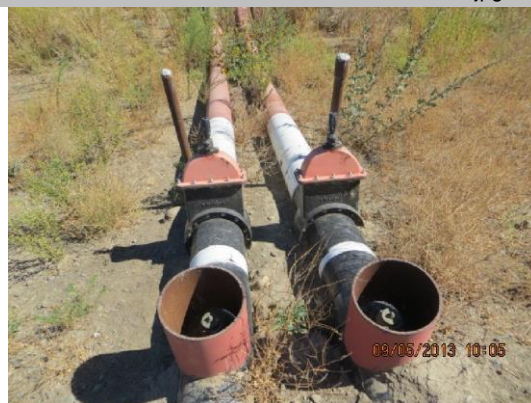
Photo 3 of 3 : UCIP_SP_2017_22285_38008.jpg

Pipe, gate valve, and siphon breaker visible on WS slope.

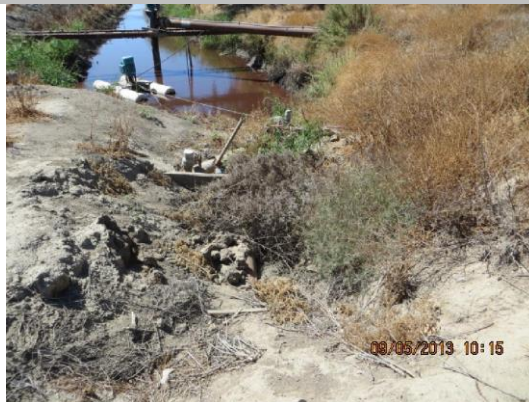
Photo 2 of 3 : UCIP_SP_2017_41351_62267.jpg

Pipe visible at bottom of ditch on LS toe.

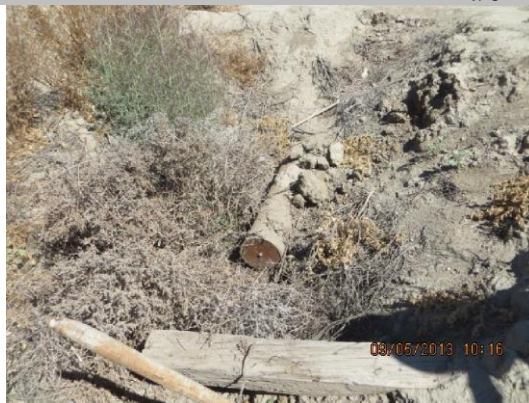
Photo 3 of 3 : UCIP_SP_2017_41351_62266.jpg

LM Start	1.41	Rating **	M	Issue No.	58 (cont)
LM End	1.41	Issue Type +	Ma	Location *	LS
Category	Supplemental			GPS Latitude/Longitude	
				Start	End
Item	DWR UCIP LMA Responsibility			37.714049 °	37.714049 °
				-121.288426 °	-121.288426 °
DWR ID					
Comment Code					
Inspector Comment					
FS_ID:41351 DS_ID:20679 EP_NO: 3975 Repair Type: Non-Urgent Crossing Status: Found UCIP Comments: Pipe abandoned and should be done so properly. Large hole in ground over pipe on WS berm. Pipe rusted through on WS at river bank. No connection to pump on LS toe. FIELD_STRUCT_DESC: *ABANDONED* 10-inch steel stormdrain pipe through the levee 4-feet below the crown. Steel plate over pipe end at pump station on LS toe. Siphon breaker in 24-inch corrugated metal riser unit on the waterward shoulder (Permit No. 3975, 1962). Originally included in the 1968 O&M manual. FS Date: 9/5/2013

Pipe visible at bottom of ditch on LS toe.

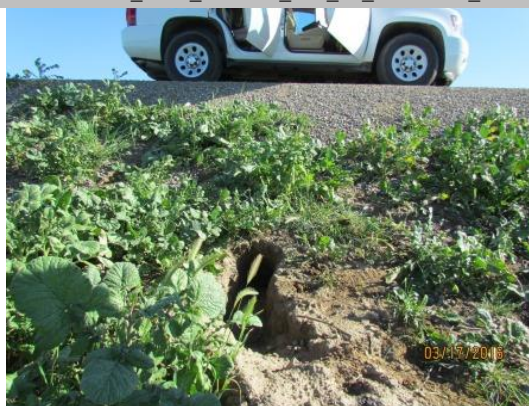
Photo 1 of 1 : SP_2017_RD2085_113_39_20170407_00022.jpg

LM Start	1.63	Rating **	M	Issue No.	43
LM End	1.63	Issue Type +	Ma	Location *	LS
Category	Earthen Levee			GPS Latitude/Longitude	
				Start	End
Item	Animal Control			37.712676 °	37.712676 °
				-121.284732 °	-121.284732 °
DWR ID	DWR_RD2085_01_s_2017_43				
Comment Code					
A3 : No rodents visible, but rodent burrows visible; need to backfill and compact or grout burrows.					
Inspector Comment

View of the rodent burrows on the landside levee slope.

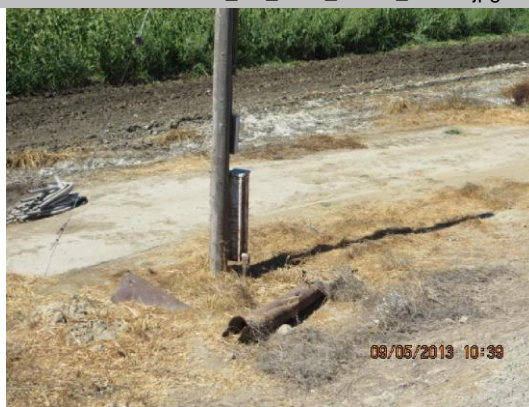
Photo 3 of 3 : UCIP_SP_2017_19423_32960.jpg

Power pole on LS toe.

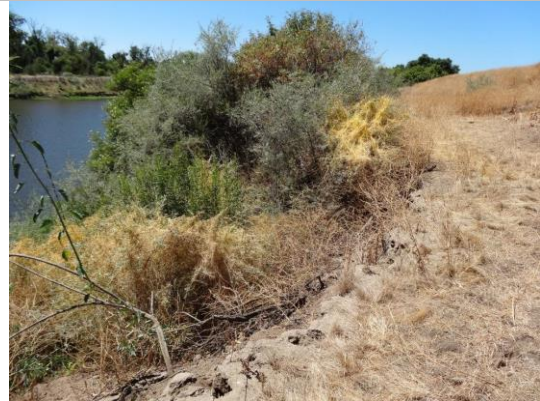
Photo 1 of 3 : SP_2017_RD2085_113_1_20170407_00001.jpg

121.274894 °	121.274894 °
DWR ID	DWR_RD2085_01_s_2017_1				
Comment Code					
Inspector Comment					
07/08/2016: No significant change observed.					
09/10/2015: No significant change observed. Signs of animal activity are present.					
09/10/2014: No significant change observed.					
09/20/2013: No significant change in erosion observed. More vegetation at the site.					
12/04/2012: The erosion has progressed remarkably toward levee, extended to the up-and downstream of the original pocket erosion. Trees and dense bush are present at the site. Animal burrow holes are visible, and possibly can cause seepage.					
09/22/2010: No significant change observed. There is little visibility due to seasonal grass on the berm and slope.					
08/18/2009: Site is located on berm; pocket erosion has developed; the site is covered in dense vegetation; there are several relief wells on the landside of the levee; site is Not Rated because berm width is greater than 30 feet; site should be monitored to keep track of erosion progress. [2016 Site ID:RD2085U01RM66.5]

Close view of the erosion.

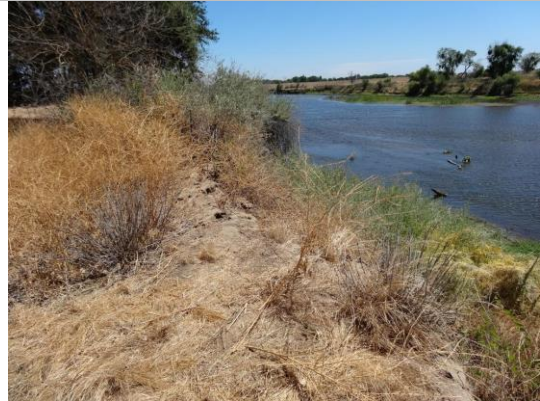
Photo 2 of 3 : SP_2017_RD2085_113_1_20170407_00002.jpg

Direct view of the erosion. Note the dense vegetation at the site.

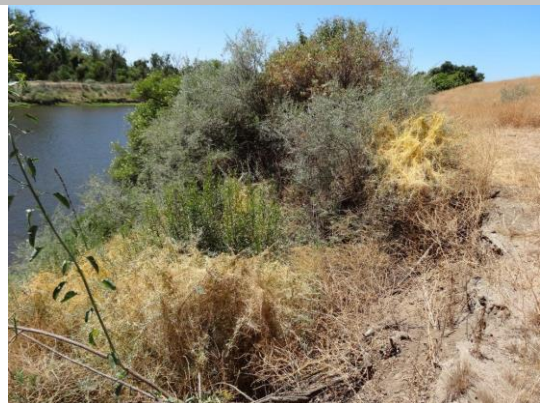
Photo 3 of 3 : SP_2017_RD2085_113_1_20170407_00003.jpg

Close view of the erosion.

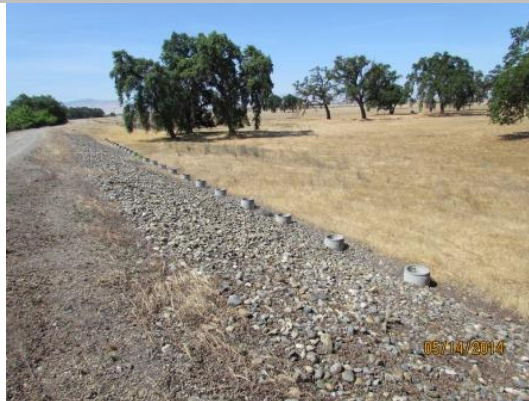
Photo 1 of 1 : SP_2017_RD2085_113_20_20170407_00011.jpg

View of the underseepage relief wells at the landside levee toe.

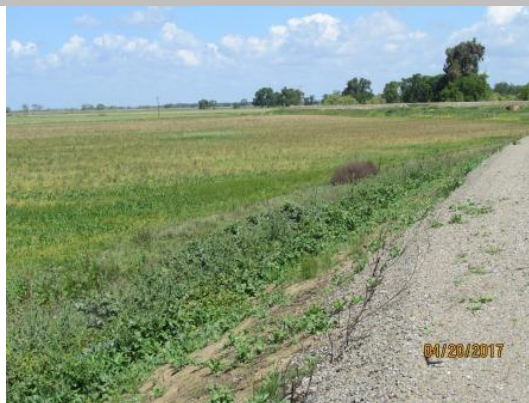
Photo 1 of 1 : SP_2017_RD2085_113_41_20170421_00066.jpg

View of the vegetation on the landside levee slope.

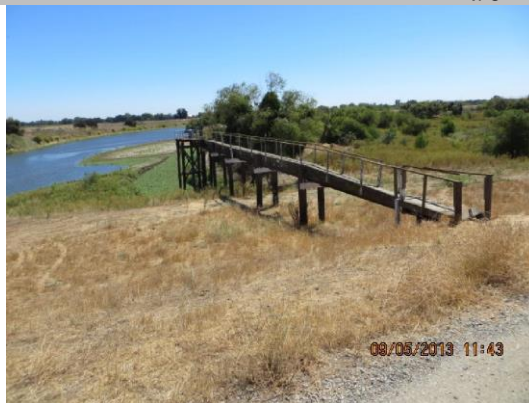
Photo 1 of 3 : UCIP_SP_2017_19431_32983.jpg

LM Start	2.82	Rating **	M	Issue No.	60
LM End	2.82	Issue Type +	En	Location *	LS
Category	Supplemental			GPS Latitude/Longitude	
				Start	End
Item	DWR UCIP Field Study			37.699698 °	37.699698 °
				-121.276325 °	-121.276325 °
DWR ID					
Comment Code					
Inspector Comment					
FS_ID:19431					
DS_ID:20688					
EP_NO: 16970					
Repair Type: Non-Urgent					
Crossing Status: Found					
UCIP Comments: The wooden walkway on the WS slope is in disrepair.					
FIELD_STRUCT_DESC: 1 of 2: 14-inch steel irrigation pipe through the					
levee 2.0 feet below the crown. Pump on wooden pier at WS slope.					
Siphon breaker visible next to steel bollard on LS slope. Power pole on					
LS toe.					
FS Date: 9/5/2013

Pump on Wooden pier at WS slope.

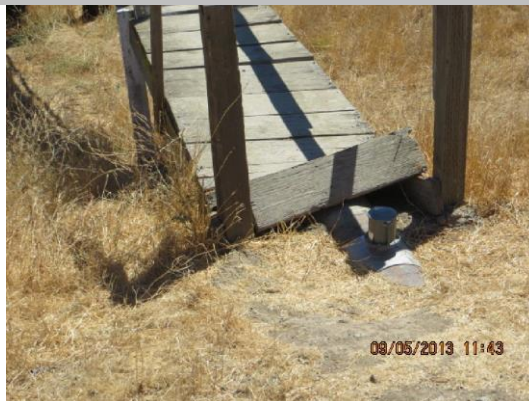
Photo 2 of 3 : UCIP_SP_2017_19431_32982.jpg

Pipe visible under walkway on WS slope.

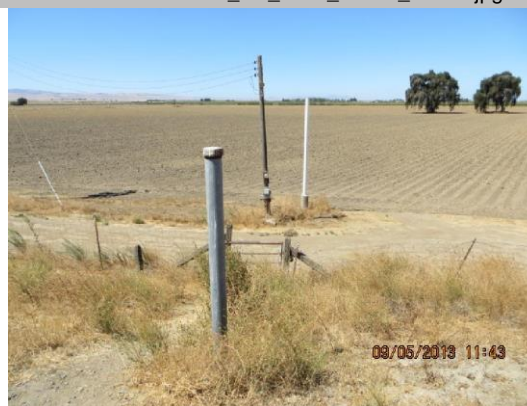
Photo 3 of 3 : UCIP_SP_2017_19431_32981.jpg

LM Start	2.82	Rating **	M	Issue No.	60 (cont)	
LM End	2.82	Issue Type +	En	Location *	LS	
Category	Supplemental			GPS Latitude/Longitude		
				Start	End	
Item	DWR UCIP Field Study			37.699698 °	37.699698 °	
				-121.276325 °	-121.276325 °	
DWR ID						
Comment Code						
Inspector Comment						
FS_ID:19431						
DS_ID:20688						
EP_NO: 16970						
Repair Type: Non-Urgent						
Crossing Status: Found						
UCIP Comments: The wooden walkway on the WS slope is in disrepair.						
FIELD_STRUCT_DESC: 1 of 2: 14-inch steel irrigation pipe through the						
levee 2.0 feet below the crown. Pump on wooden pier at WS slope.						
Siphon breaker visible next to steel bollard on LS slope. Power pole on						
LS toe.						
FS Date: 9/5/2013

Power pole on LS toe with possible PVC riser.

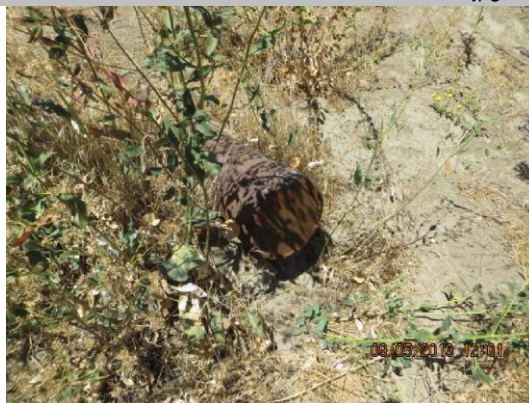
Photo 3 of 3 : UCIP_SP_2017_19433_32988.jpg

Pipe visible on WS slope. Steel plate welded over end.

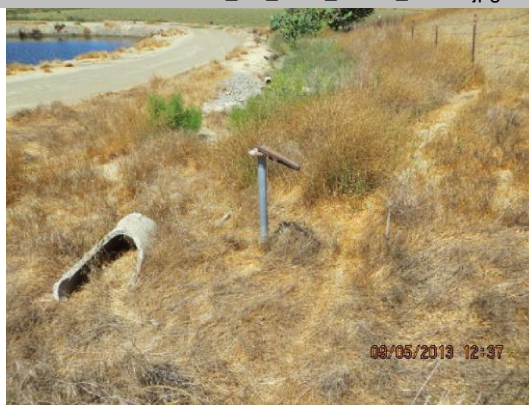
Photo 1 of 3 : UCIP_SP_2017_19435_32993.jpg

LM Start	3.42	Rating **	M	Issue No.	62
LM End	3.42	Issue Type +	En	Location *	WS
Category	Supplemental			GPS Latitude/Longitude	
				Start	End
Item	DWR UCIP Field Study			37.691966 °	37.691966 °
				-121.278122 °	-121.278122 °
DWR ID					
Comment Code					
Inspector Comment					
FS_ID:19435 DS_ID:20687 EP_NO: 16970 Repair Type: Non-Urgent Crossing Status: Found UCIP Comments: Appears abandoned and if so should be done so properly. FIELD_STRUCT_DESC: *ABANDONED* 2 of 2: 10-inch steel stormdrain pipe through the levee 2-feet below the crown. Appears to connect to pump 150-feet off LS toe. Possible butterfly valve at LS toe. Vent on WS shoulder. Steel plate welded over pipe end on WS toe. FS Date: 9/5/2013

Possible Butterfly valve at LS toe.

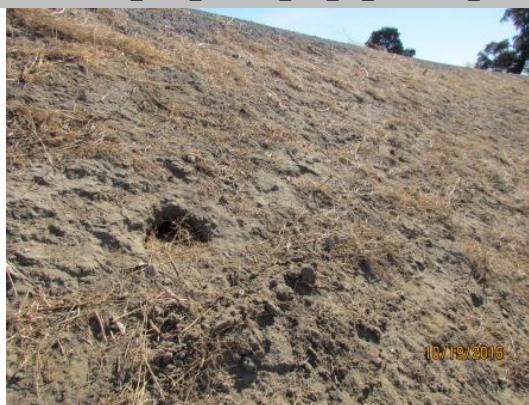
Photo 1 of 2 : SP_2017_RD2085_113_45_20170407_00023.jpg

View of the rodent burrows on the landside levee slope. Fall 2016

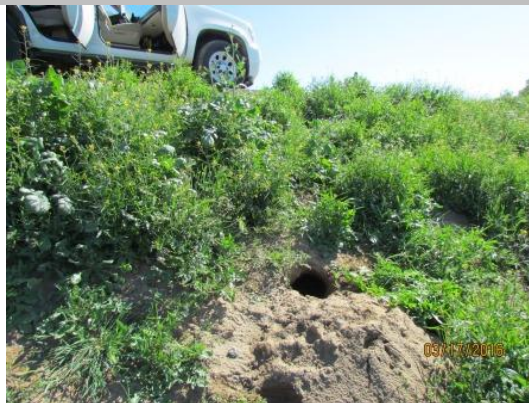
Photo 2 of 2 : SP_2017_RD2085_113_45_20170407_00024.jpg

View of the rodent burrows on the landside levee slope.

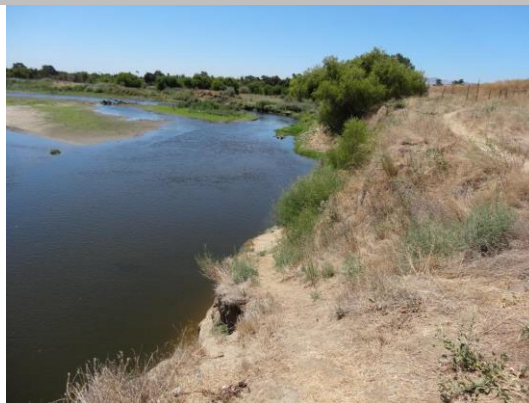
Photo 1 of 3 : SP_2017_RD2085_113_2_20170407_00004.jpg

View of the downstream end of the erosion.

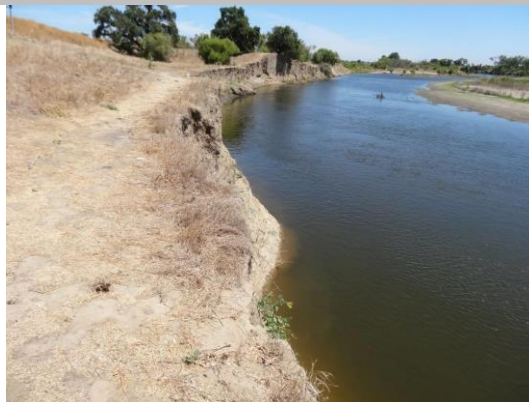
Photo 2 of 3 : SP_2017_RD2085_113_2_20170407_00005.jpg

Close view of the erosion.

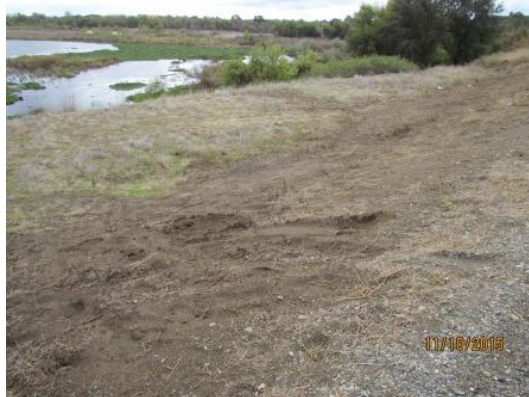
Photo 1 of 1 : SP_2017_RD2085_113_25_20170407_00012.jpg

View of the waterside levee slope damaged by vehicle.

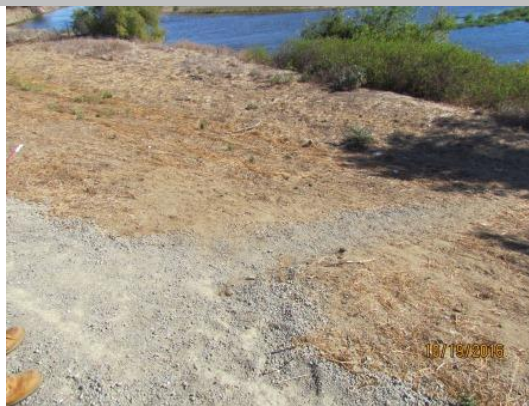
Photo 1 of 1 : SP_2017_RD2085_113_26_20170407_00013.jpg

View of the foot path on the levee slope.

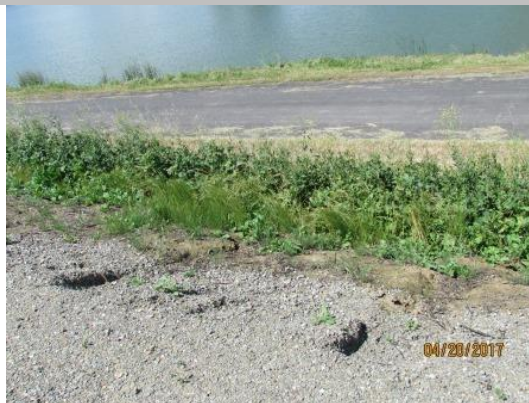
Photo 1 of 1 : SP_2017_RD2085_113_46_20170421_00065.jpg

View of the tire tracks on the levee slope.

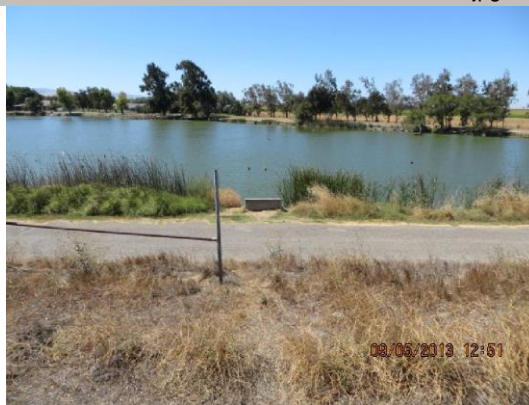
Photo 2 of 3 : UCIP_SP_2017_19436_32996.jpg

Concrete headwall off LS toe.

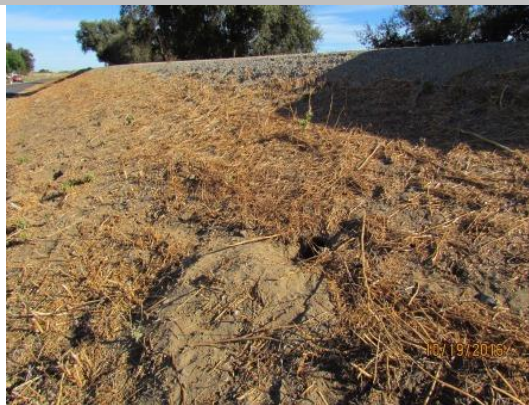
Photo 1 of 1 : SP_2017_RD2085_113_36_20170407_00021.jpg

View of the rodent holes on the levee slope.

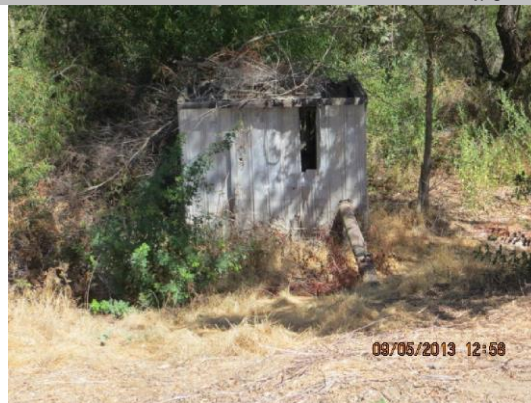
Photo 1 of 3 : UCIP_SP_2017_19443_33002.jpg

Pumphouse and pipe visible on WS toe.

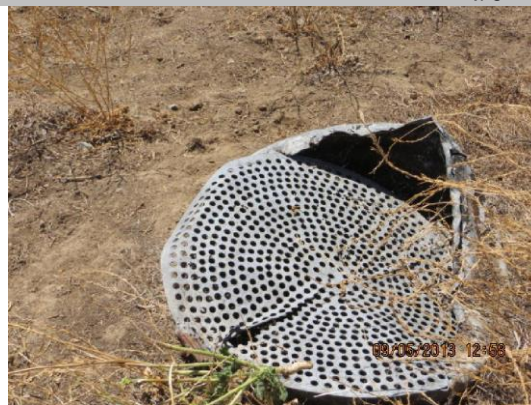
Photo 2 of 3 : UCIP_SP_2017_19443_33001.jpg

Siphon breaker on vent in 24-inch CMP riser on LS shoulder.

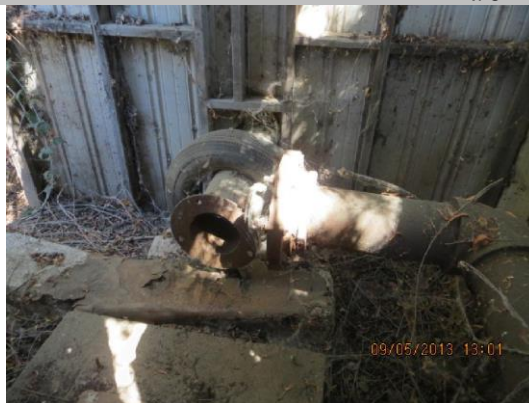
Photo 3 of 3 : UCIP_SP_2017_19443_33000.jpg

Pump missing from pipe in pumphouse on WS toe.

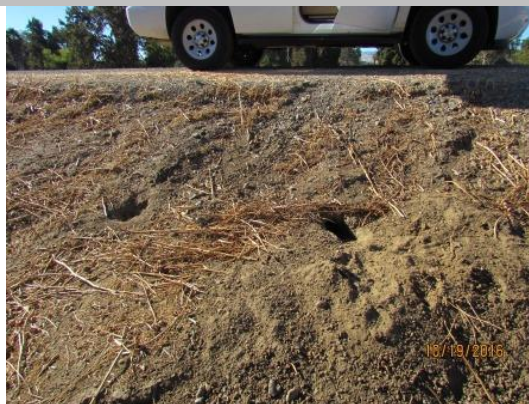
Photo 1 of 1 : SP_2017_RD2085_113_34_20170407_00020.jpg

View of the rodent holes on the levee slope.

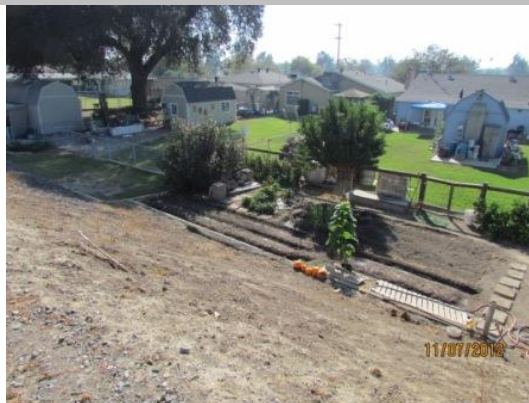
Photo 1 of 2 : SP_2017_RD2085_113_33_20170407_00018.jpg

Updated photo of encroachments on landside toe.

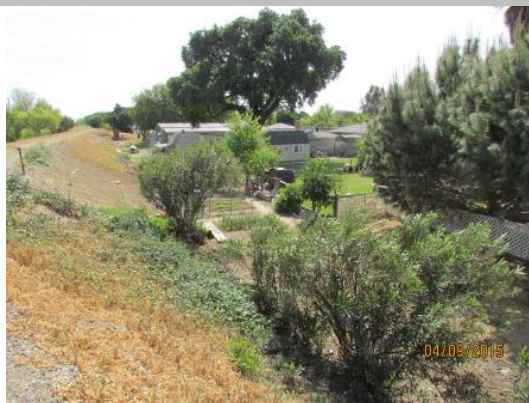
Photo 2 of 2 : SP_2017_RD2085_113_33_20170407_00019.jpg

View of the landscaping at the landside levee slope.

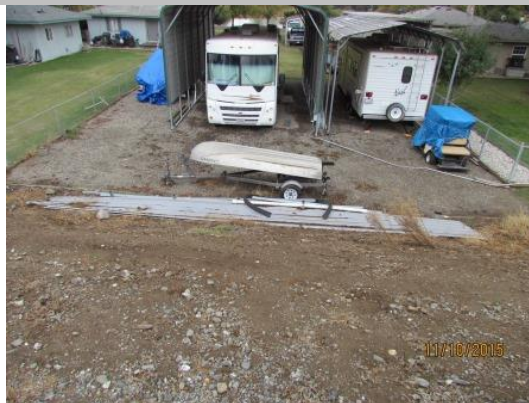
Photo 1 of 1 : SP_2017_RD2085_113_27_20170407_00014.jpg

View of the material stored at the landside levee toe.

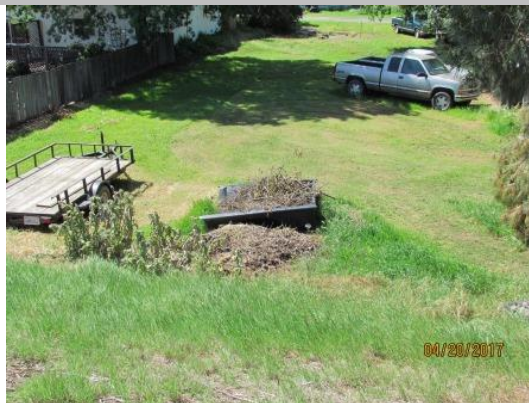
Photo 1 of 1 : SP_2017_RD2085_113_17_20170421_00064.jpg

View of the firewood and debris stored at the landside levee toe.

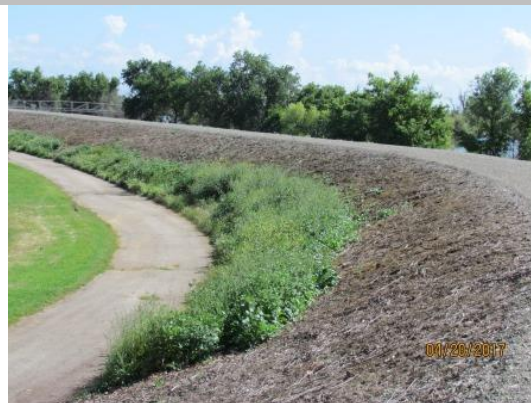
Photo 1 of 1 : SP_2017_RD2085_113_40_20170421_00063.jpg

View of the vegetation on the landside levee slope.

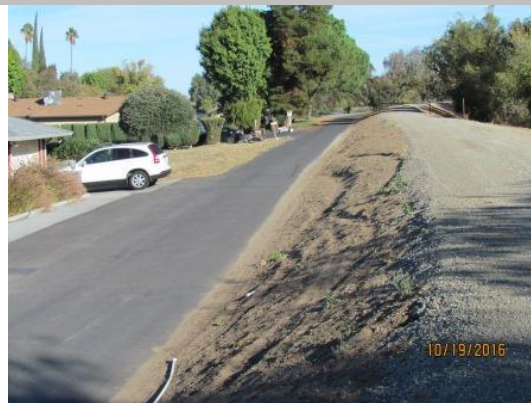
Photo 1 of 1 : SP_2017_RD2085_113_52_20170407_00026.jpg

View of the tire tracks on the levee slope.

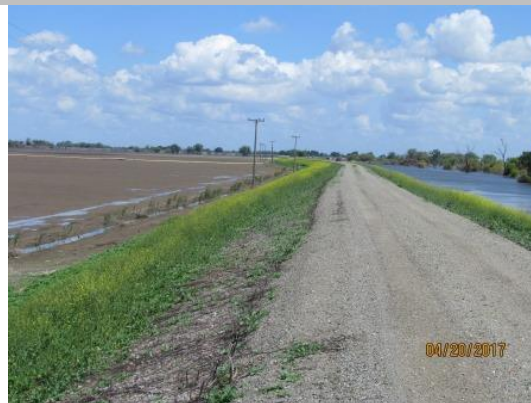
Photo 1 of 1 : SP_2017_RD2085_114_1_20170421_00001.jpg

View of the vegetation on the levee slope.

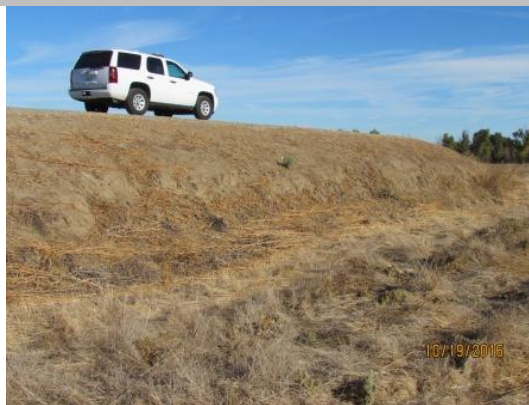
Photo 2 of 3 : SP_2017_RD2085_115_1_20170407_00001.jpg

View of the erosion at the waterside levee toe. Fall 2016.

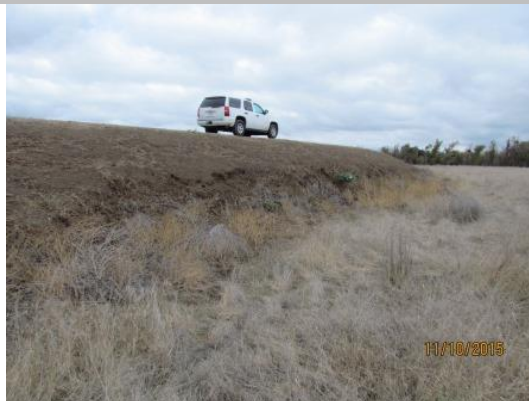
Photo 3 of 3 : SP_2017_RD2085_115_1_20170407_00002.jpg

View of the erosion at the waterside levee toe.
